**Property Inspection Report**

1600 Anywhere, Beaverton, OR 97007 Inspection prepared for: John Doe Date of Inspection: 5/1/2019 Time: 1:00 pm Age of Home: Built 2017 Size: 3127 sq ft Weather: Overcast

Inspector: Don Grossarth CCB #204194, OCHI #1736 1527 Maple Street, Forest Grove, OR 97116 Phone: 503-881-7031 Email: oregonnwhomes@gmail.com oregonnwhomes.com

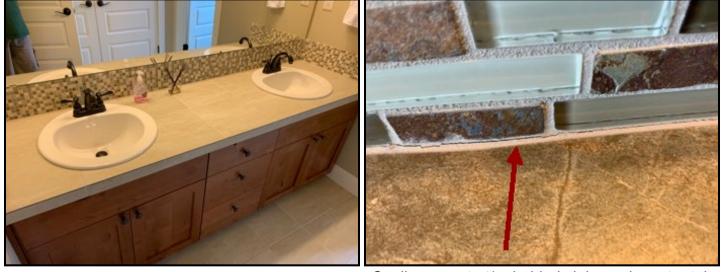
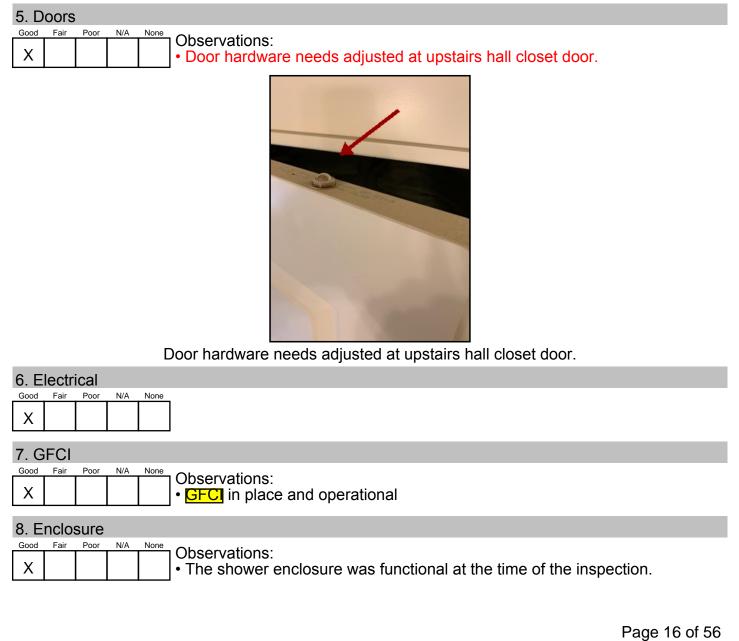
#### 4. Counters

Caulk or grout at/or behind sinks and master tub as needed.

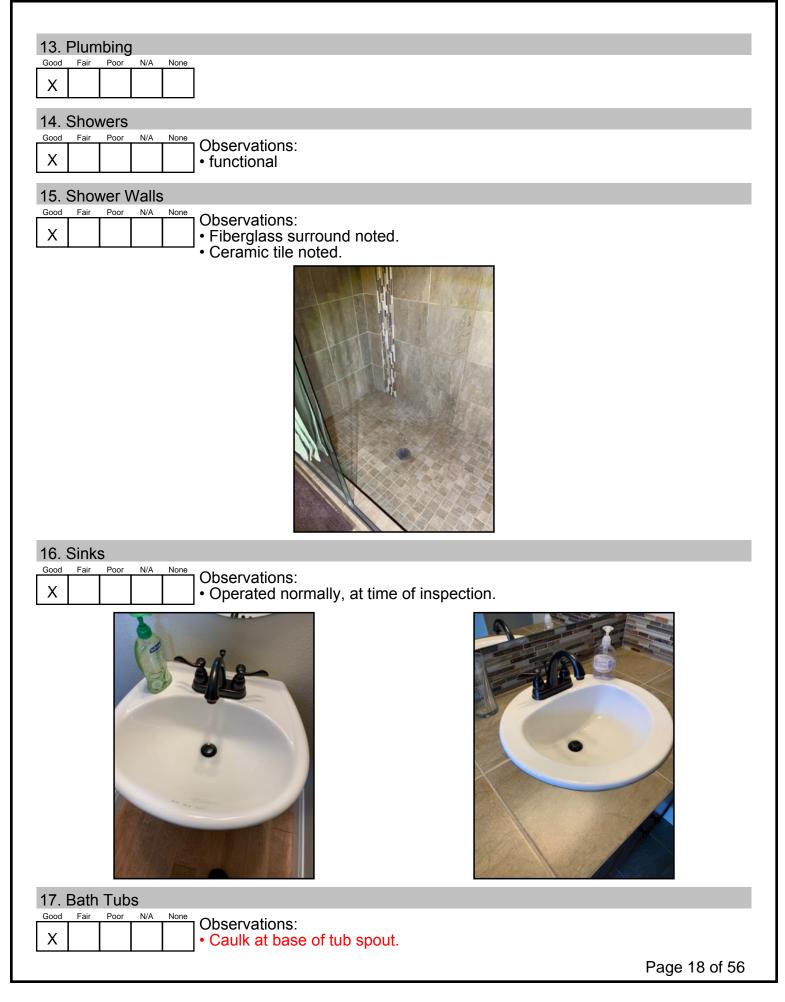
Caulk at base of tub spout.

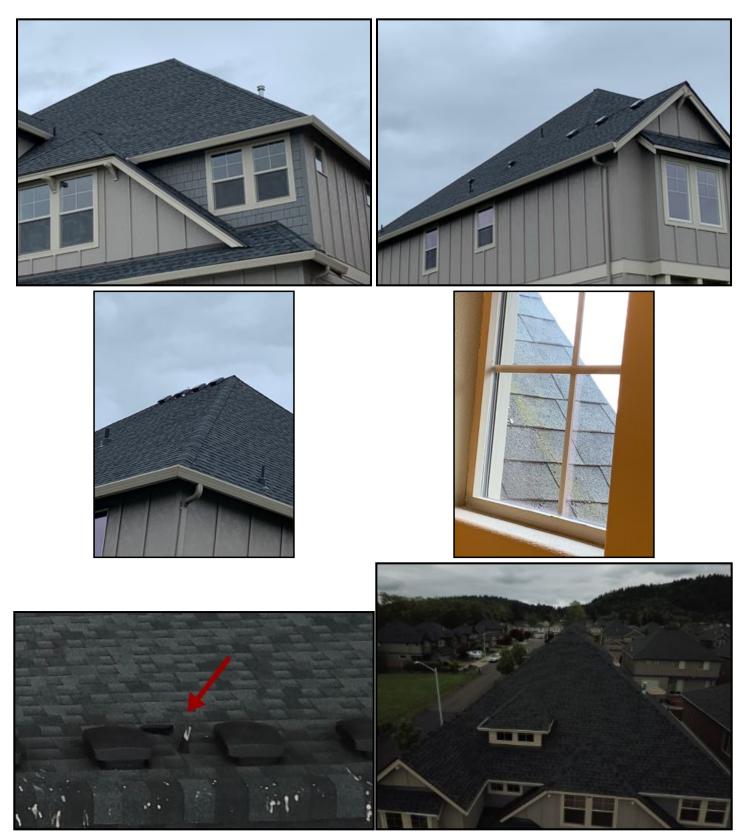
Roof anchors covers are not in place. This can lead to rust on the anchors. Recommend roof anchor covers are placed over anchors.

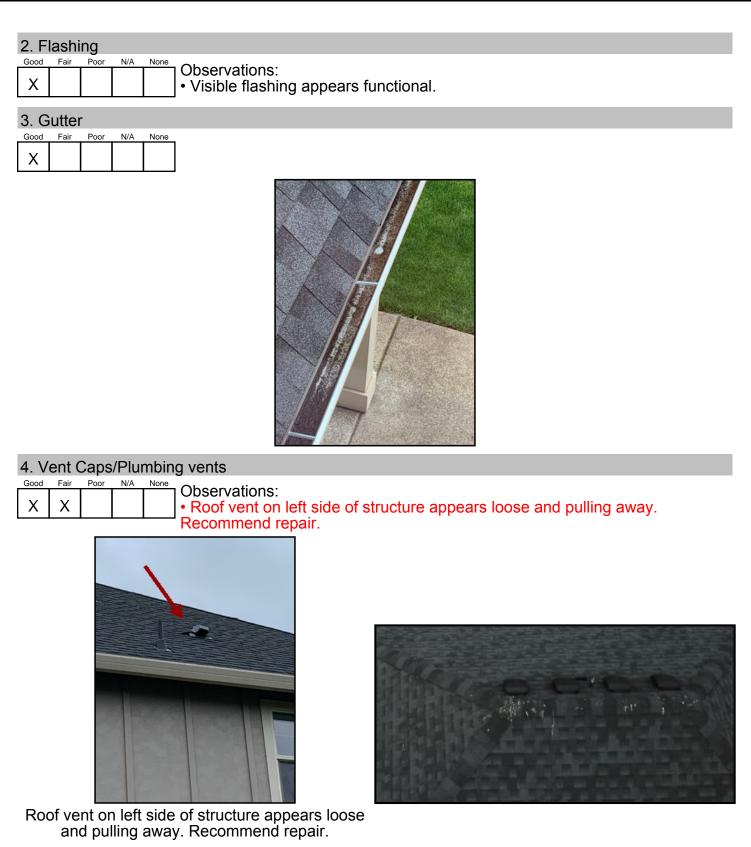
Roof vent on left side of structure appears loose and pulling away. Recommend repair.

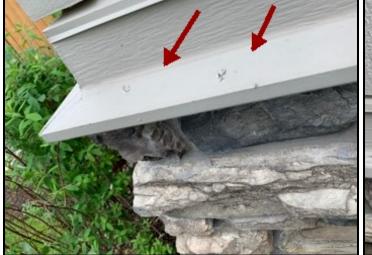
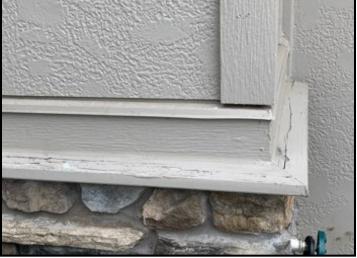
Good	Fair	Poor	N/A	None	Observations: • All exterior painted wood trim surfaces should be annually examined and sealed, re-caulked and re-painted as needed.
					• Peeling paint observed on trim. suggest scraping and painting as necessary.
120	1 152	A CONTRACTOR

Peeling paint observed on trim. suggest scraping Peeling paint observed on trim. suggest scraping and painting as necessary.

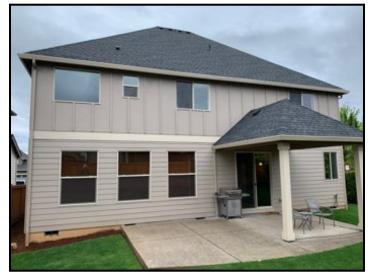
### 4. Siding Condition

- Appears functional.
- Recommend flashing over decorative beams to prevent Decay.

#### Recommend flashing over decorative beams to prevent Decay.
